In The Garage

Feb 2025

Issue 21

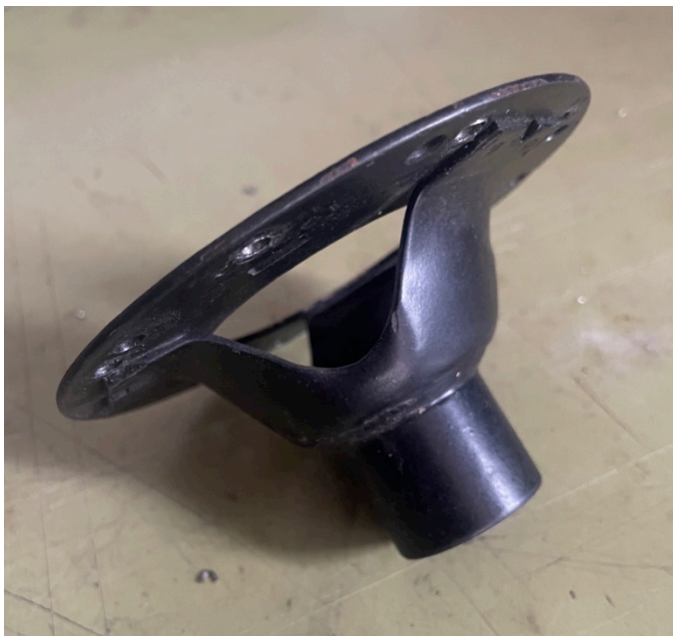
The flimsy looking fabricated Astralli boss is usually covered with a plastic shroud

I've used a fabricated Astralli steering wheel boss for some time while waiting for a sensibly priced Moto Lita one to come along. The correct B1 bosses are few and far between but I was able to buy a B1-OE for a Mini Cooper that has the same spline, taper and basic casting. It was simply modified by machining out the horn push recess and outer column clearance recess to fit the TR3.

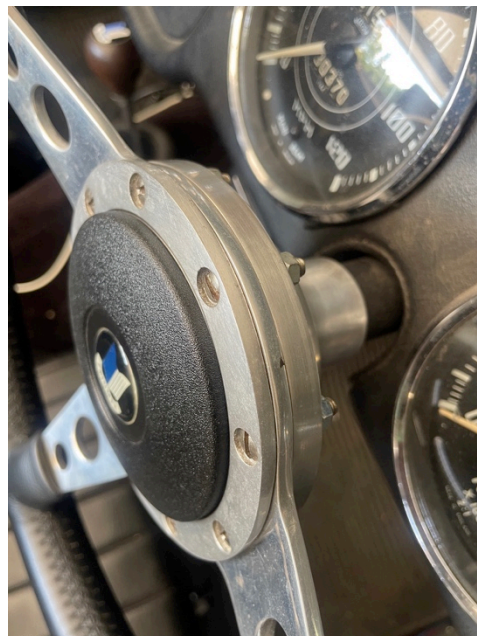
The standard Moto Lita fixings

Once fitted it struck me that the slotted countersunk screws and exposed nuts and washers didn't add to the aesthetics. So off it came again for a bit more modification. The nine screw holes in the boss were drilled, tapped and Helicoiled M5 and the fixing screws were replaced with M5 x 20 stainless steel pan head screws with a hexagon drive.

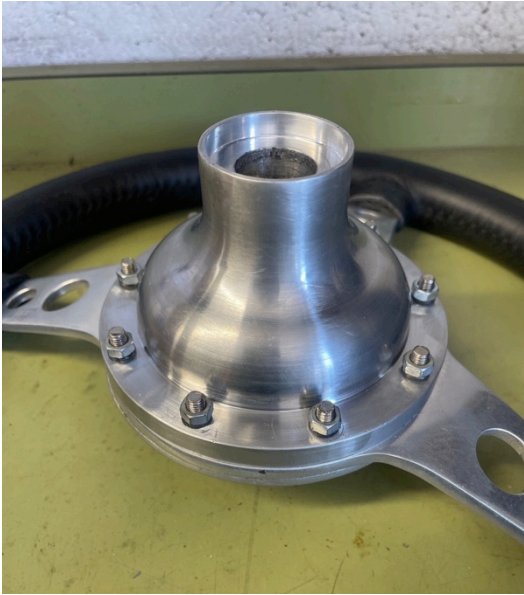
With standard screws and nuts.

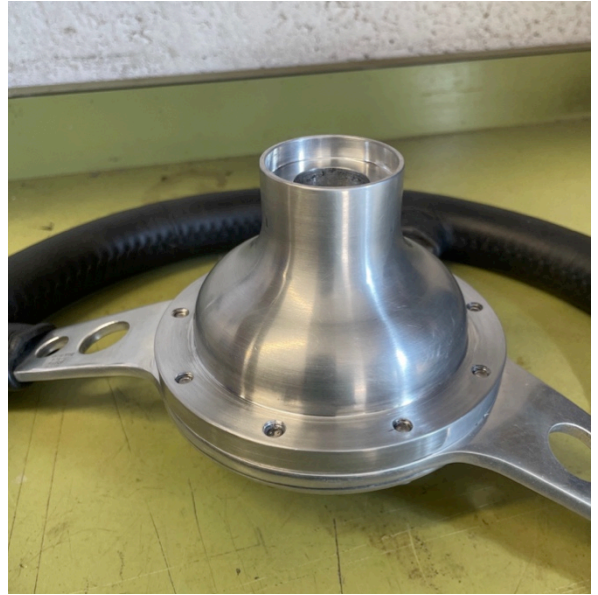
With Helicoils. The machined recess which covers the top of outer column and column top bush can also be seen here.

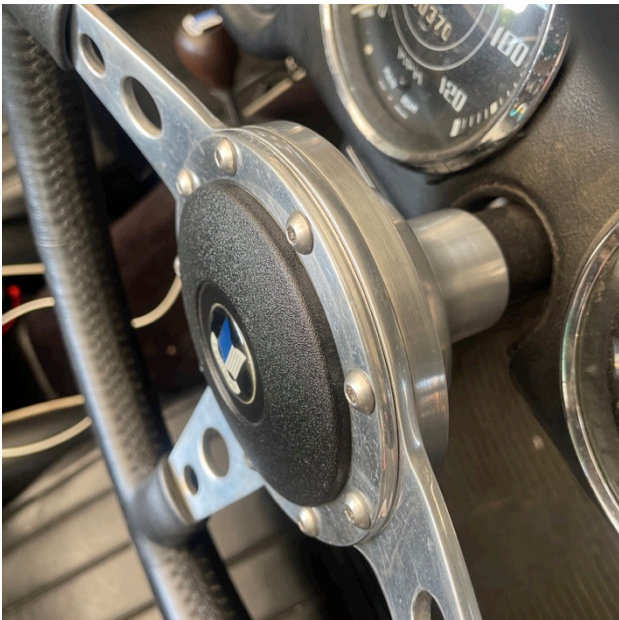
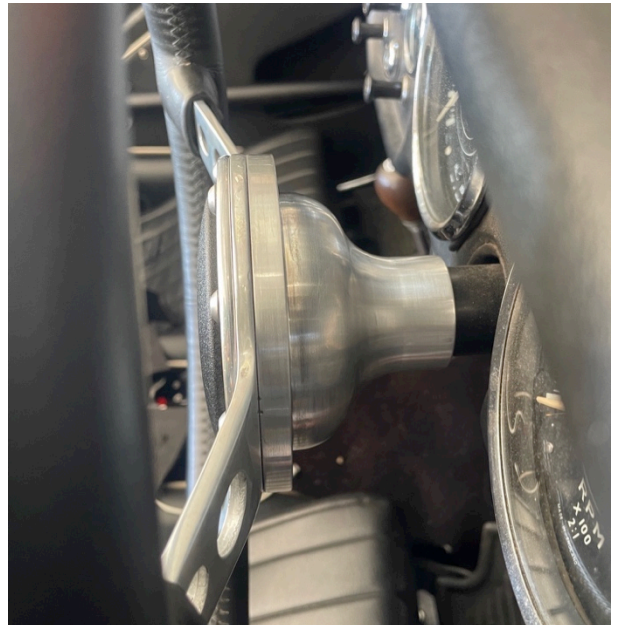
I'm sure that anyone who spots the difference will agree that the modified fixing presents a much cleaner finish, but I'm equally sure that no one will notice it except me. My neighbour thinks that I'm watching too much "Kindig Customs"

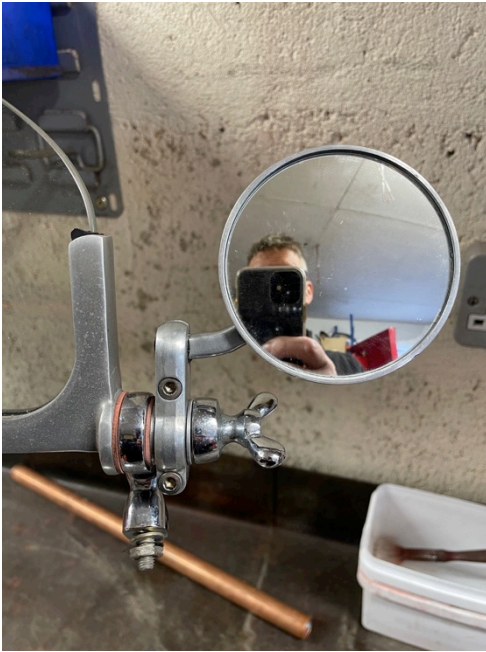
TR3 Wing Mirrors

Fitting wing mirrors to a side screen car has always been problematic and has resulted many innovative solutions. I recently spotted these machined aluminium mirrors in a neighbours garage. They are designed to fit on the end of a motorcycle handlebar but we found them to be a direct fit to a Brooklands Aeroscreen and easily adapted to fit onto the windscreen stanchion attachment bolts. They can be sourced quite cheaply from eBay.

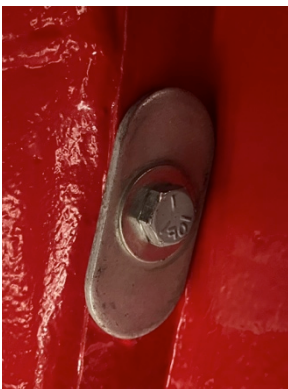
Wing Fixings

While helping John Evans assemble his MGA restoration I noticed the special wing attachment washers, which I thought may be useful on early TRs. The washers are elongated and made from a heavy gauge material that will resist the cupping often seen on TRs. The elongated shape spreads the clamping force over a greater area than the much smaller TR washers and is large enough to cover the oversize slotted holes in the wings that form a dirt trap on TRs. The MG washers have a 5/16" hole rather than the 1/4" hole needed for a TR so they were used with a backing washer when tried on my TR3.

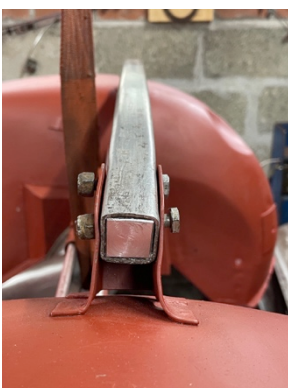
Front Valance Support

The aluminium tube that supports the top of the nosecone on early TRs is very soft and usually deforms before I consider the attachment bolts tight enough. While the car was in pieces I made aluminium inserts to fit in the ends. The bolts can now be fully tightened without deforming the tube.

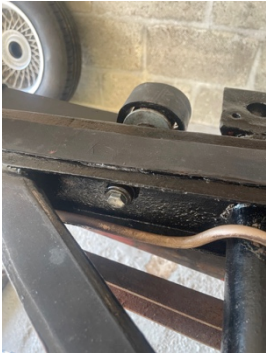
Front Spring Mount

The front spring attachment pin on live axle cars can be difficult to remove and to that end Triumph has provided a 5/16"UNF thread on the inner end to attach a puller or slide hammer. These blind holes are often filled with road dirt, under seal, rust or other detritus that can be difficult to clean out. I fit a screw and washer smeared with copper grease to protect the thread

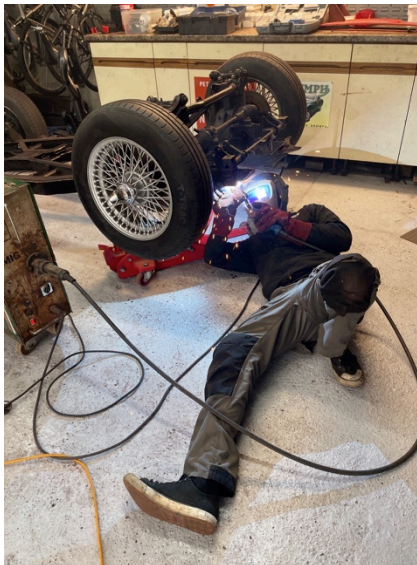
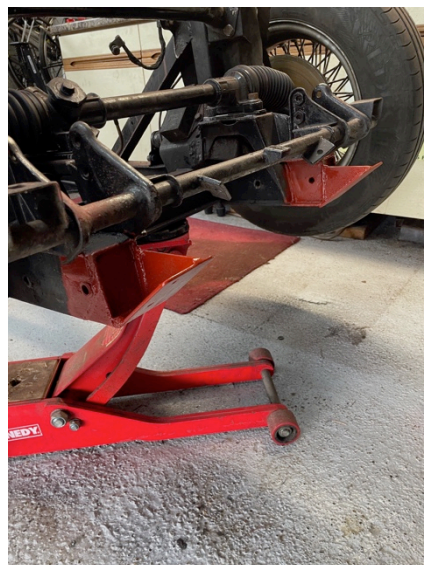
Front ARB Brackets

Front anti-roll bar brackets are usually a bolt on item that sharing fixings with the front bumper mountings. As I don't envisage ever running without an anti roll bar I decided to weld new ARB mounts direct to the front of the chassis. I tacked the brackets into position but was struggling with the vertical and inverted welding. Bob Dove Racing's Mikey Dove came to the rescue and made a nice job of the welding.

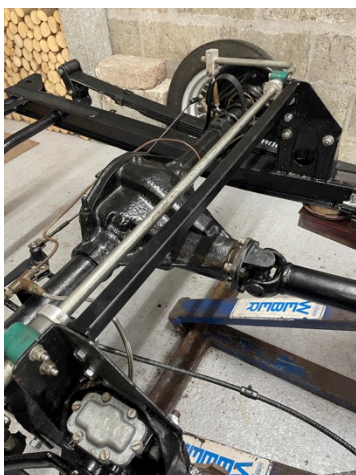
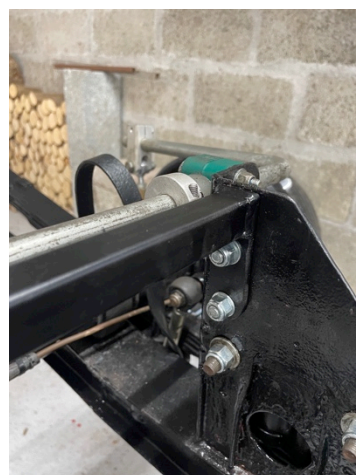
Shock Absorber Bracket Reinforcement

Shock absorber mounts are typically reinforced with webs welded to their back face extending onto the chassis rail. My rear anti roll bar mounts are welded to the top of the shock absorber mounts and seem to present an ideal location for a strut to join both mounts together across the car, significantly increasing their rigidity. I couldn't see an obvious downside, so given that it would only be an hour's work to make, I set to and got it fitted. I'm not aware of this being done before; perhaps I'll find out why when I come to re-fit the body ☺

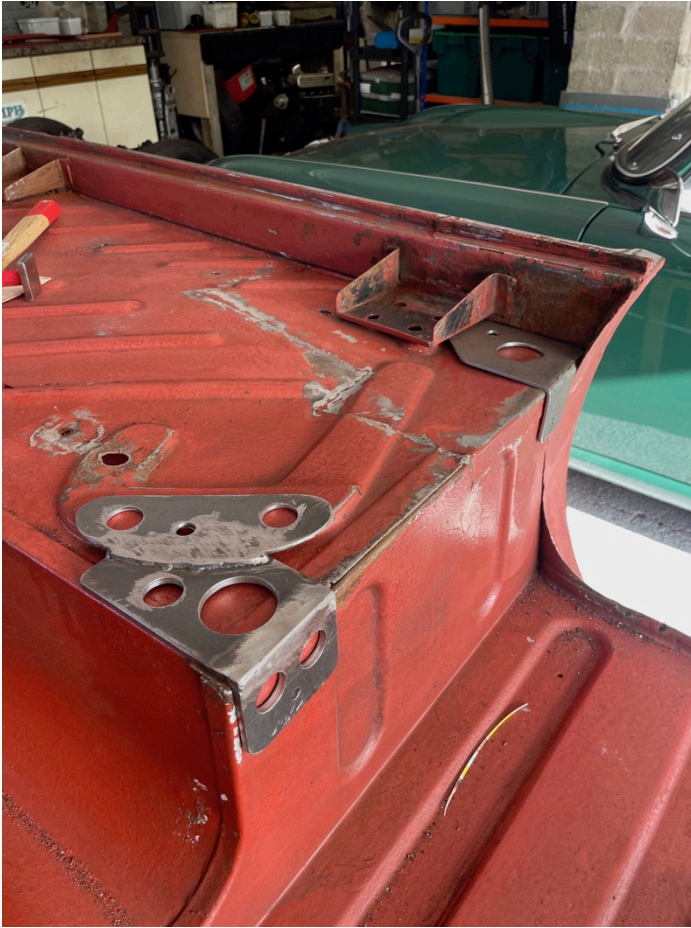
Seatbelt Mountings

The four point harnesses in the TR3 have been fitted for some time but I've never been happy with the floor mountings that comprised eyebolts in the floor pan reinforced with large washers. Race regulations require them to be secured into a triangulated section of the bodywork so that seemed to be a good starting point for road use too.

I fabricated some admittedly heavy brackets to bolt under the floor and then made a token attempt to lighten them by cut I a few holes. The results are shown in the picture taken while the tub was inverted.

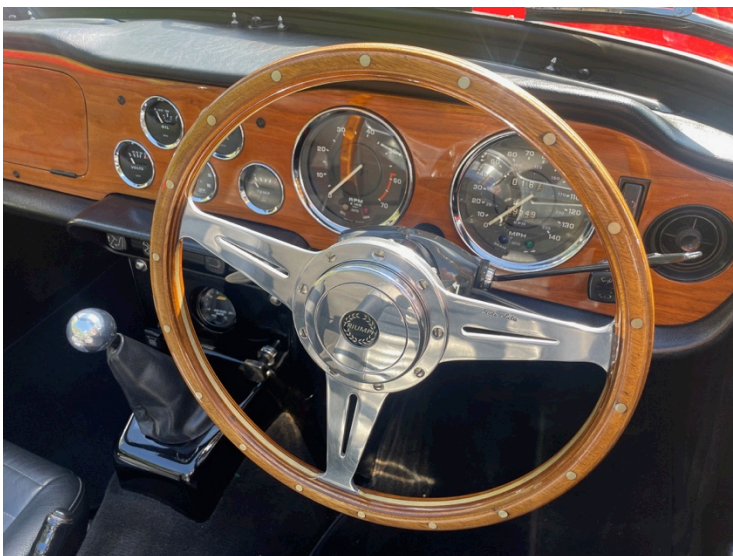
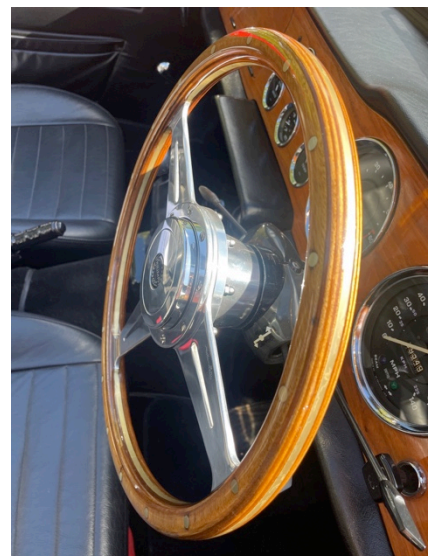
Steering Wheel Boss Upgrade

Paul has recently found time to fit the polished horn push, which he purchased at the IWE. The sharp-eyed will notice a nice little detail; polished, domed nuts used to secure the wheel to the boss.

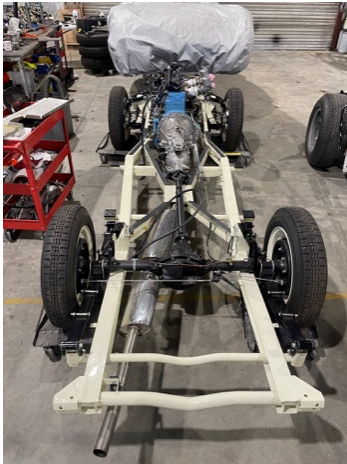
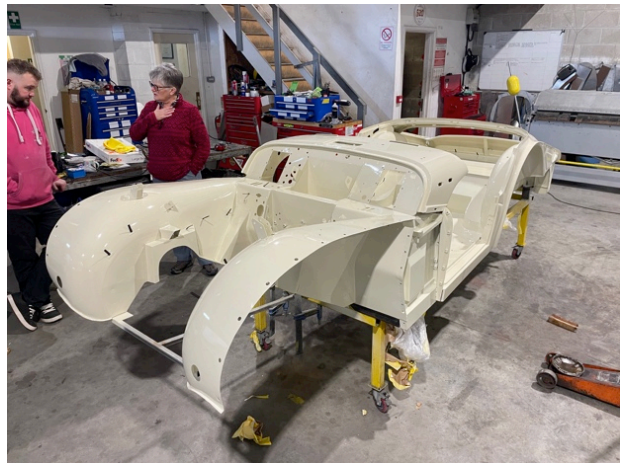
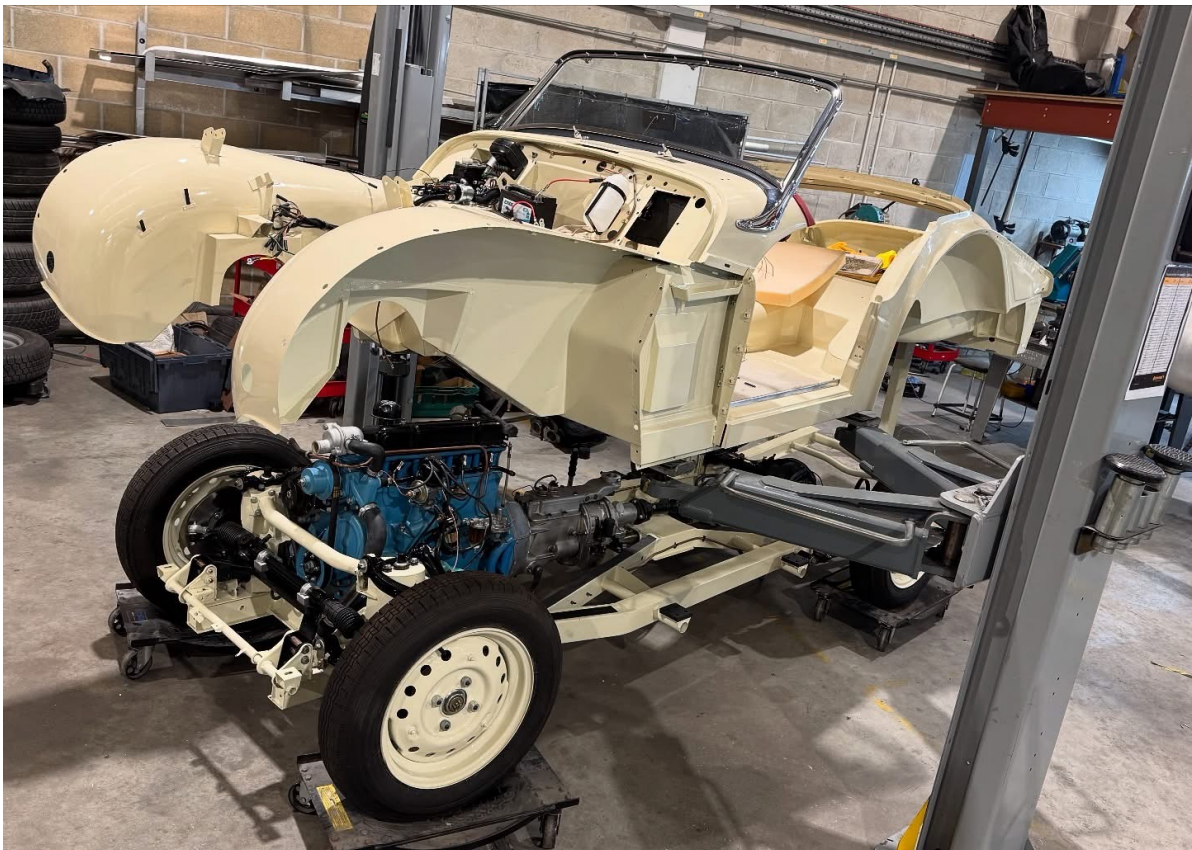
Final Build Now Underway

A recent visit to North Devon Metalcraft found that Pauls TR2 tub had returned from the paint shop resplendent in it's 2k paintwork. The body was fitted out as much as possible prior to being reunited with the completed chassis.

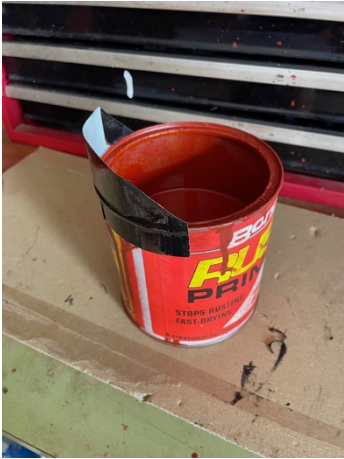
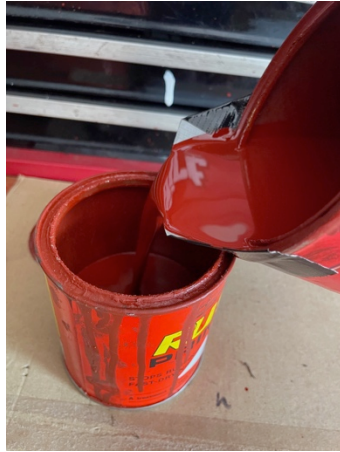
Paint Pouring Tip

When decanting paint from tins I've found it useful to stick a piece of Duct Tape to the edge of the tin forming a temporary spout. When finished it gets removed and goes straight into the bin greatly reducing the usual mess.
